Utilizing MRail's vertical track deflection measurements to identify and quantify the risk of soft spots in track for maintenance prioritization

FRA Track & Railroad Workplace Safety Symposium
April 6, 2022

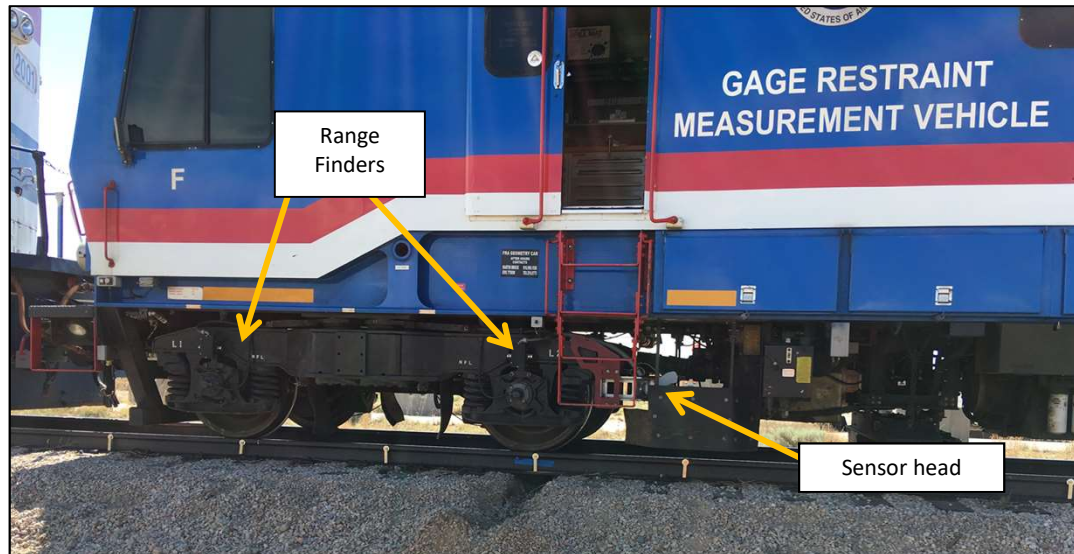
- DOTX218 MRail system is a special case
 - DOTX218 has a secondary suspension
 - Laser range finders are used to identify the additional bogie movement caused by the suspension
 - DOTX218 MRail system is integrated into the car's master control software
 - Data capture is triggered by system
 - Data can be aligned with other measurement systems on vehicle
 - System is powered by the car's shore power system

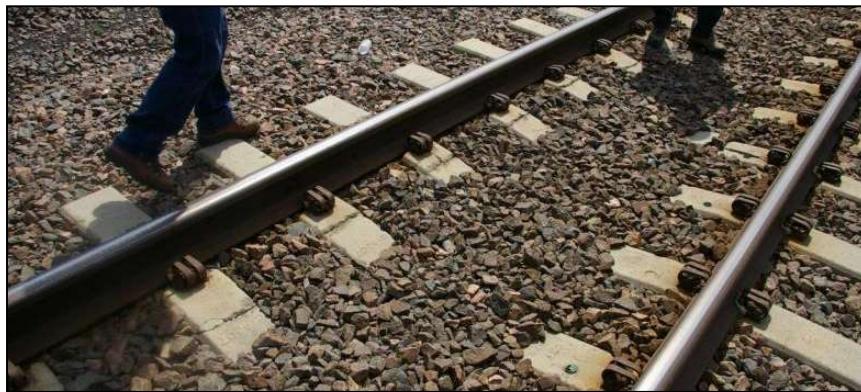
- Examples where track geometry will miss track issues but *MRail* will not
 - Soft in soft out support issues
 - Areas of track where low g-forces are experienced going from one support condition to another
 - The train is eased in and out of soft area of track
 - Continuous regions of soft ballast or sub-grade
 - Regions of continuous tie failures
 - Regions where point of deflection is higher than surroundings
 - When the track deflects, the high spot deflect in line with the surrounding rail
 - Track geometry would register no significant change in acceleration

Typical track geometry systems are inertial based. In order for a location to be flagged as an exception, sufficient accelerations (g-forces) need to be measured.

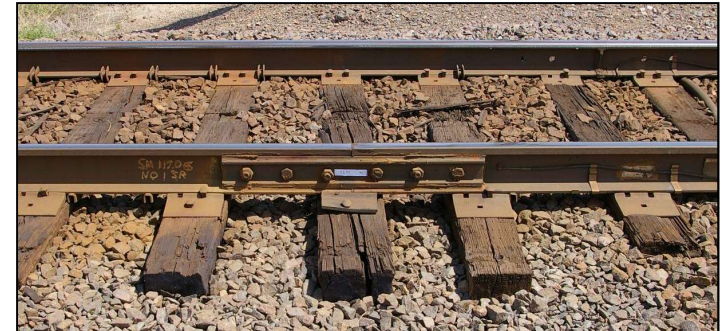
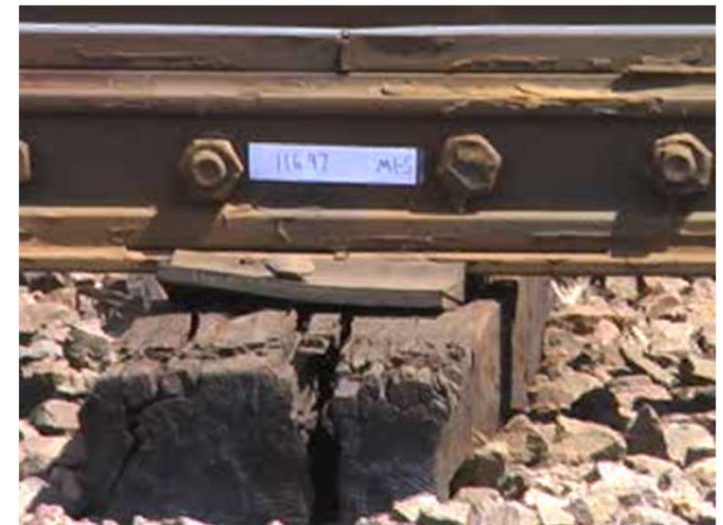
Although track geometry (ECO) shows a small deviation from the norm, it was insufficient to cause concern due to smooth transition. *MRail* (YRel) was able to quantify the severity of the structural issue.

Video of broken tie deflection smoothing rail profile

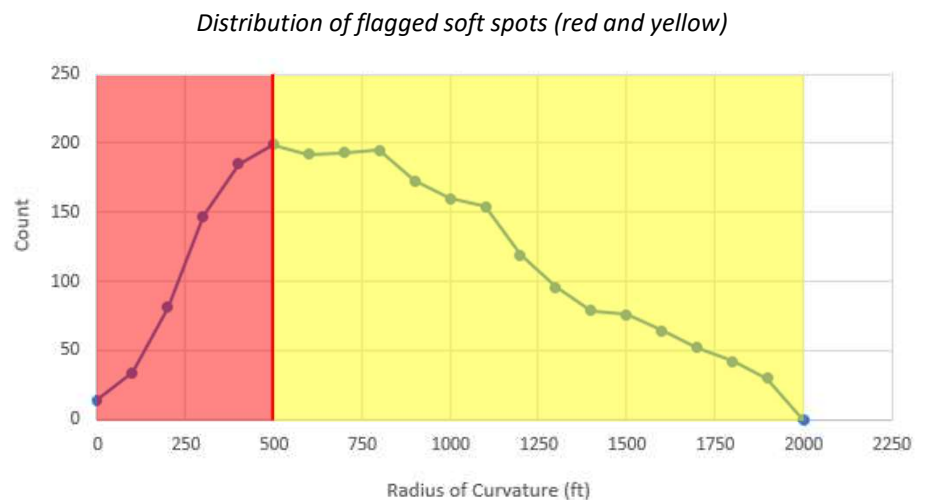
Single inspection movement summary

- A single inspection run from Butler, PA to Punxsutawney, PA was used to guide this process
 - ~50 miles of track
- 2285 location flagged
 - Left / right independent
 - 461 red
- Highest concentration from 500 to 800 ft RoC

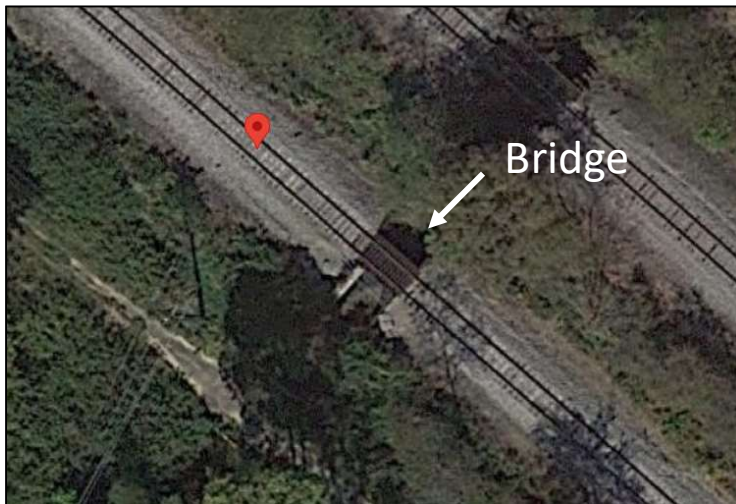
General Site Description:
Approach to short bridge

Google Maps image of location

Item	Comment
Site Description	Approach to a short bridge
Ballast fouling present	NO
Ballast fouling level (0 – 3)	0
Issues observed	YES Lifted rail Bridge cap indenting

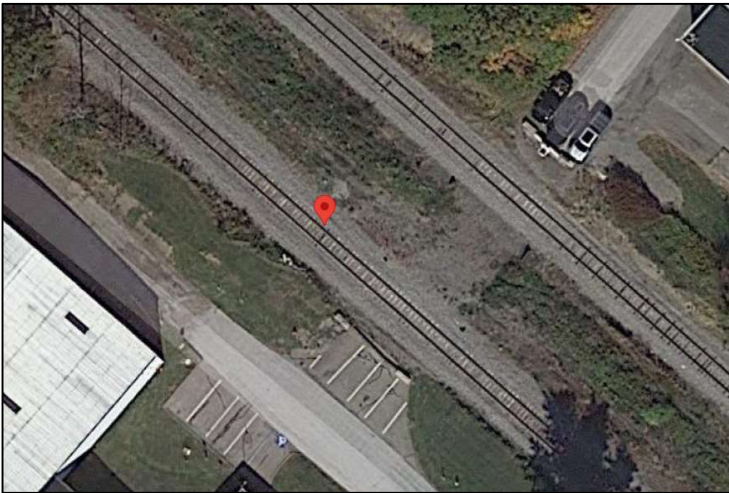
General Site Description:
Plainline track

Google Maps image of location

Item	Comment
Site Description	Plainline track
Ballast fouling present	YES
Ballast fouling level (0 – 3)	1
Issues observed	YES Mud

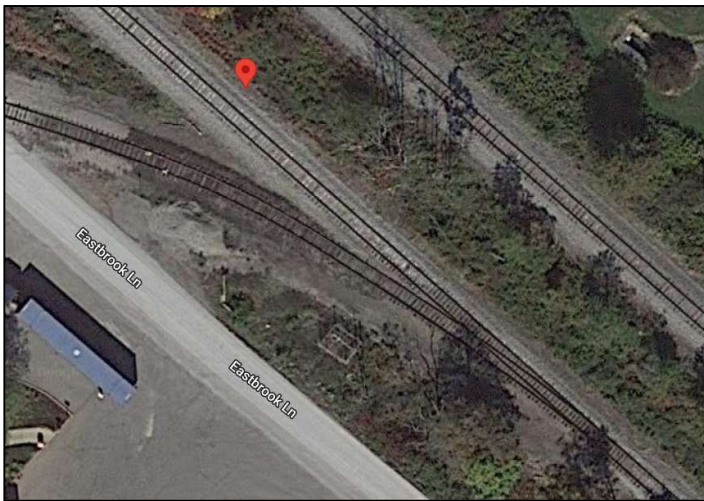
General Site Description:
Trailing approach to turnout

Google Maps image of location

Item	Comment
Site Description	Trailing approach to turnout
Ballast fouling present	NO
Ballast fouling level (0 – 3)	0
Issues observed	YES Broken ties

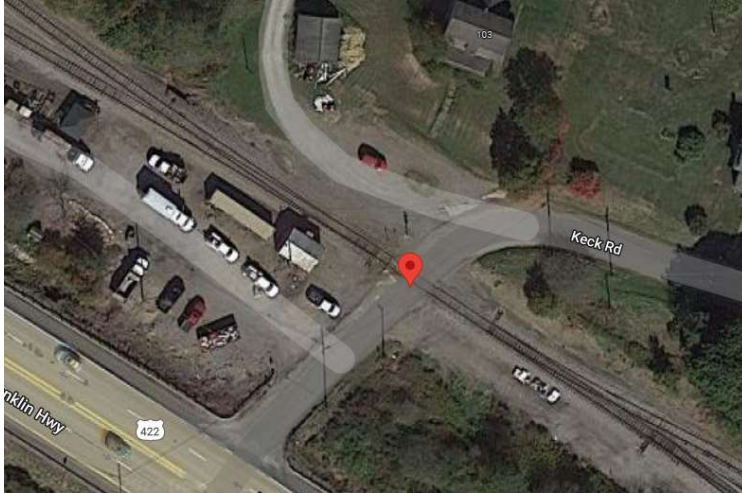
Turnout/Grade Crossing/Turnout

Google Maps image of location

- No observable issues photographed
- Lots of special track work
- Informed that grade crossing “hits hard”
 - May explain some of the issues found in the area

Item	Comment
Site Description	Turnout/Crossing/Turnout
Ballast fouling present	NO
Ballast fouling level (0 – 3)	0
Issues observed	NO

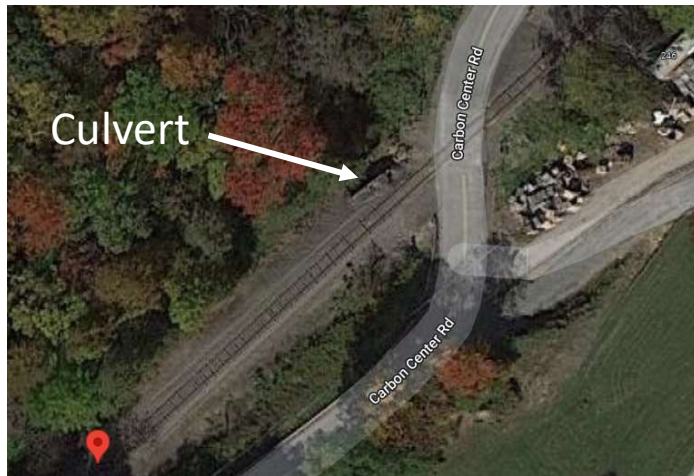
Area around grade crossing with culvert

Google Maps image of location

Item	Comment
Site Description	Grade cross + culvert
Ballast fouling present	YES
Ballast fouling level (0 – 3)	2
Issues observed	YES Mud Mud pumping Tie plate cutting into tie

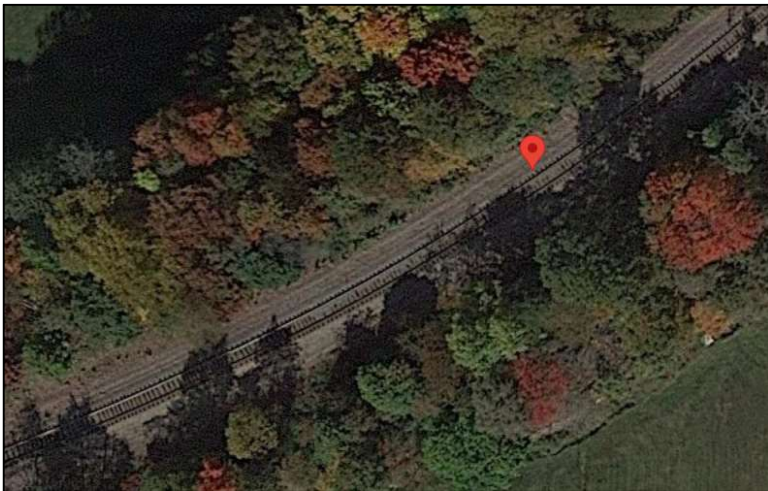
General Site Description:
Plainline track in curve

Google Maps image of location

Item	Comment
Site Description	Plainline in curve
Ballast fouling present	YES
Ballast fouling level (0 – 3)	1
Issues observed	YES Mud pumping Only on high side

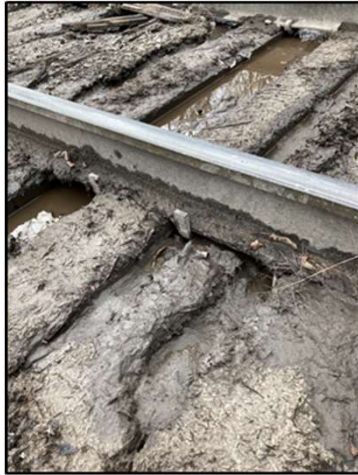
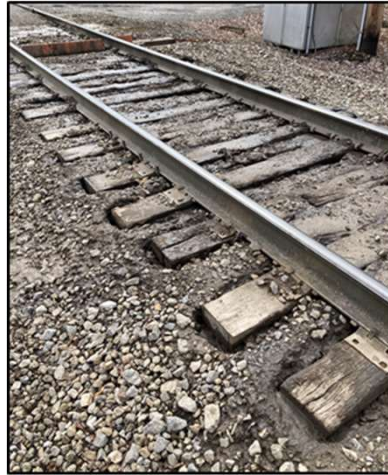
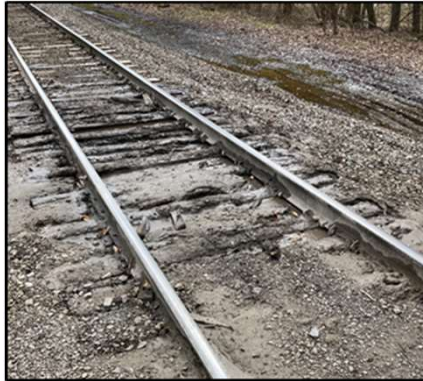
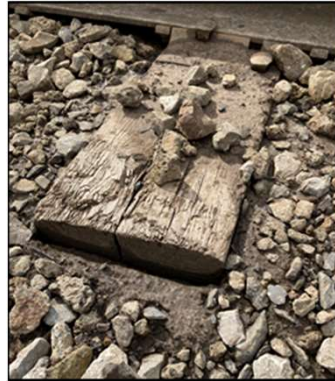
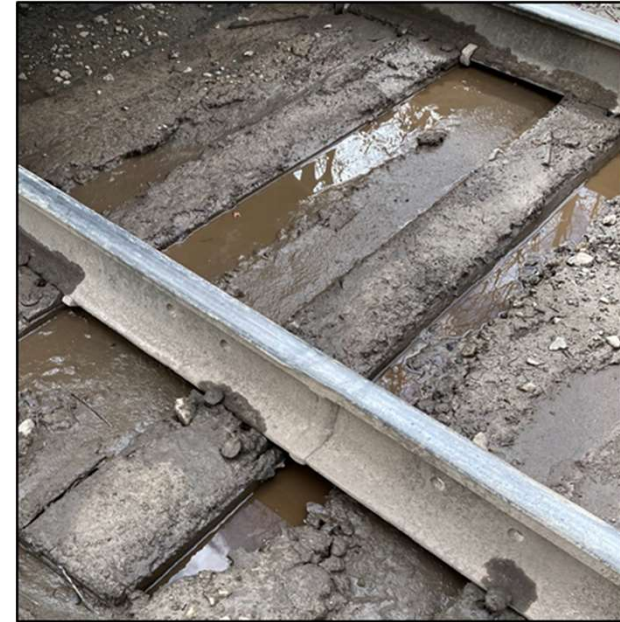
Item	Comment
Site Description	Around grade crossing
Ballast fouling present	YES
Ballast fouling level (0 – 3)	3
Issues observed	YES Heavy presence of mud Standing water
